"STUDY OF MAINTENANCE STRATEGY PROVISIONS BASED ON FUNCTIONAL EVALUATION OF PAVEMENTS"

A THESIS

BACHELOR OF TECHNOLOGY

CIVIL ENGINEERING

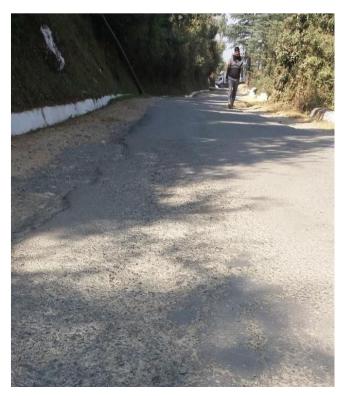
Fig.1.1: Roughness on flexible pavement

Roughness is defined as an unwanted deviation of the surface of the pavement compared to its smooth surface. It causes the vehicles to vibrate leading to reduce in the comfortability while riding. The I.Resistance Index is the most generally used factor for measuring roughness. The values are in units meter per kilometer (m/km).

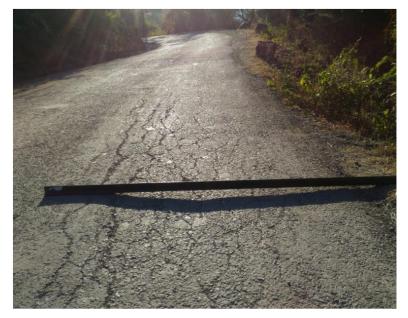
Fig.1.2:Rutting on the road surface

Rut can be described as a depression in the surface of the pavement on the wheel path as shown in fig.1.2. Ruts usually occur because of the damaged and weakened load transferring capacity of the pavement.

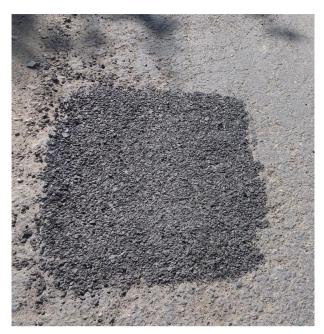
Fig.1.4: Patching at RR-1

A patch is explained as the portion of the pavement that is removed and repaired. Patches indicates the repair work done on the pavement.

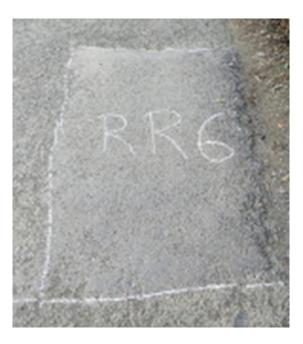
Fig.4.6: Patching at RR-6

The area of patching is evaluated by the use of instruments such as inch tape. The patched area is enclosed in rectangular or square shaped area and then the segment is measured.

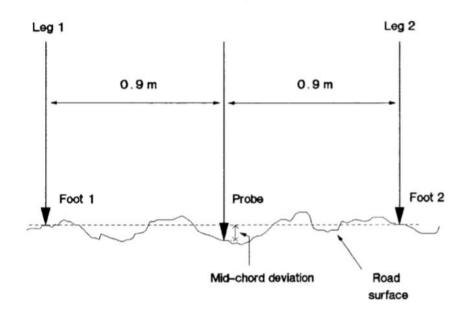
Fig. 4.10: Working Principle

This device consists of 2 feet along with a probe that rests on the ground of which the roughness is to measured. The distance of 1.8m is there between the two feet. The probe is present in the centre. This device takes up the displacement in the vertical position between the surface of the road lying below the probe and the middle point of a line that virtually joins the 2 point of contact of feet with the road. Fig.4.11 shows the working principle of MERLIN.

The rougher the surface, the more variability would be seen in the displacements.

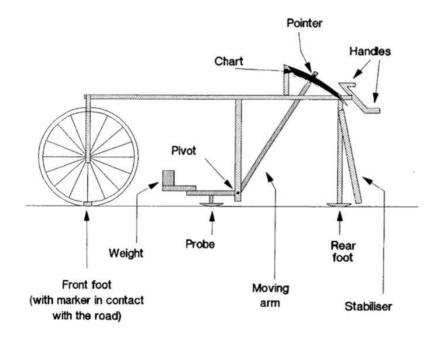
Fig.4.11: Component parts of MERLIN

The following fig.4.12 shows the component parts of MERLIN

Procedure for taking markings

On every revolution of the wheel, a reading showing the displacement in noted taking around 200 measurements. At each resting point, probe, rear foot and stabilizer should be in the contact with the road surface and the wheel should be in normal position. The operator marks the tip of the pointer on the graph representing a cross.

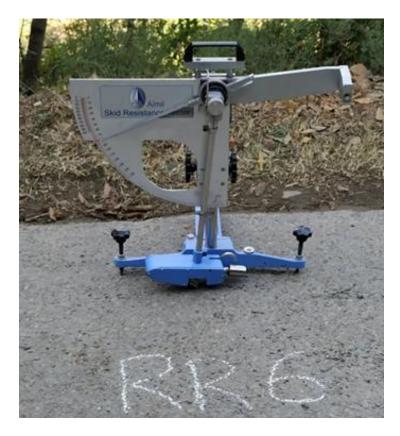
Fig. 4.13: Skid Resistance Testing at RR-6

The tester is placed and leveled on the road by adjusting legs of the instrument. The pendulum arm needs to be lowered and adjusted in such a way that the rubber stoppers just touches the surface of the road. The surface is made wet. Then the pendulum is allowed to swing and the corresponding highest value is considered. The same steps are performed for every 100m on the roads selected.

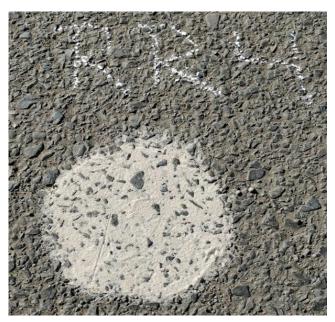
Fig.4.14: Sand Patch Test on RR-4

50 ml of fine sand with natural silica sand (grade 2) is taken and is pour onto the surface of the road and is spread in a circular manner using a 63mm round disc with a 16mm thick rubber surface touching the road surface. The surface depression gets filled to the peak level. The diameter of the circular patch formed on the surface is measured. The MTD value can be determined by the following equation:

MTD = Volume of silica sand / Area of circular patch

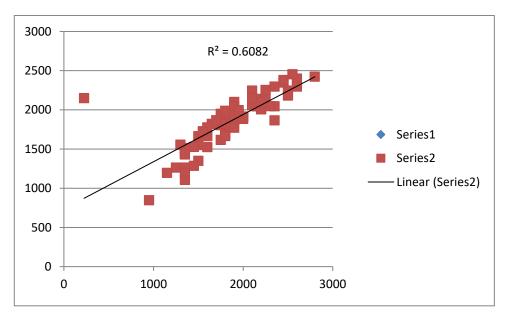
Fig.5.1: Graphical presentation of pothole data with $R^2 = 0.608$

R-squared is a measure of how closely the data are is related. It is also known as the coefficient of determination.

The figure below shows the undulations.

- 3. All the roads are safe according to the skid resistance value and surface texture depth collected and compared with the standard guidelines.
- 4. The relationship between the volume of the pothole and the mean dimensions as well as depth in not a linear equation. The linear relation cannot be established between the parameters taken up. However a non linear relation is found.

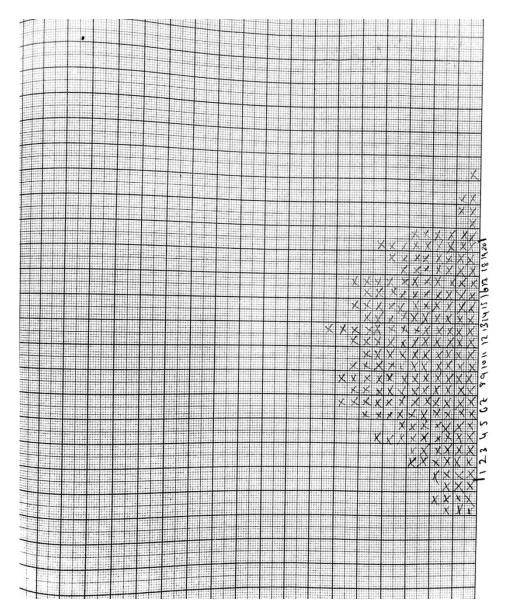
Fig.7.1: Sample graph data: RR-1

Roughness data obtained using MERLIN.
